MKR3 is the largest abandoned mine drainage (AMD) discharge in the Montour Run watershed. It issues from a 16" clay pipe (**left**) located near the headwaters of an unnamed tributary to Montour Run locally known as "Milk Run". Acid generated from the weathering of pyrite in an abandoned underground Pittsburgh Coal Seam mine lowers the pH of the groundwater resulting in aluminum being dissolved from the underlying clay strata. When the low-pH, acidic, aluminum-bearing mine drainage is mixed with alkaline water, the aluminum precipitates as a white substance, giving the stream a milky appearance (**Milk Run 2015 below**).

The Milk Run AMD Treatment System was placed online July 11, 2019 after a one-year construction period that coincided with the wettest period on record. This project was funded by a Range Resources reclamation in-lieu-of-penalty (\$949,089) which included both construction funds and \$191,000 that will be set aside for future system operation and maintenance. Additional funding was received from the U.S. Office of Surface Mining (\$180,000), the S. Kent Rockwell Foundation (\$25,000), and the Foundation for Pennsylvania Watersheds (\$20,000), as well as in-kind as

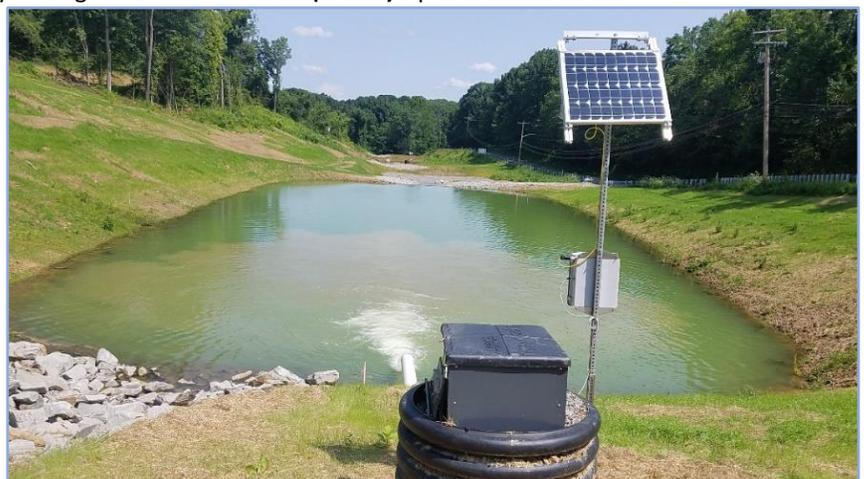
is conveyed from the abandoned mine drain via an 8" HDPE pipeline to the first Automatic Flushing Vertical Flow Pond (AFVFP1). A 1.0' H-flume allows measurement of inflow rate. AFVFP1 contains 4,000 tons of AASTHO #3 sized high calcium limestone (>90% CaCO₃) and an underdrain system with five 8" HDPE perforated lateral pipes and a single 12" header pipe that extends to a 14-foot tall Agri Drain Smart Drain. Acid is neutralized through the dissolution of limestone, raising the pH and causing the dissolved aluminum to precipitate. Once per day the Agri Drain Smart Drain (**below**) opens a 12-inch diameter valve to allow the entire volume of AFVFP1 to drain, flushing aluminum solids into Settling Pond 1 (SP1). A second Automatic Flushing Vertical Flow Pond (AFVFP2) that has 2,000 tons of similar limestone provides supplemental treatment during high flow and maintenance events. A second Smart Drain flushes AFVFP2 once per day into Settling Pond 2 (SP2).

Stream flow and stormwater are collected by the Forebay upgradient of AVFP1 and directed around the system to confluence with the effluent of SP2 just above the entrance to the Redwoods Estates Mobile Home Community.

Other than two small solar-powered programmable valve actuators, the passive system requires no electricity, has no moving parts and can operate autonomously for years. Water
